Your Futaba T26SZ transmitter programming can be updated easily online. When functions are added or improved, the update file f can be downloaded from our website. Copy the update files to the microSD card and then use the following procedure to update the program. Check our web site for the FAQ regarding updating for more information.

## **T26SZ SOFTWARE UPDATE CHANGES**

V1.3

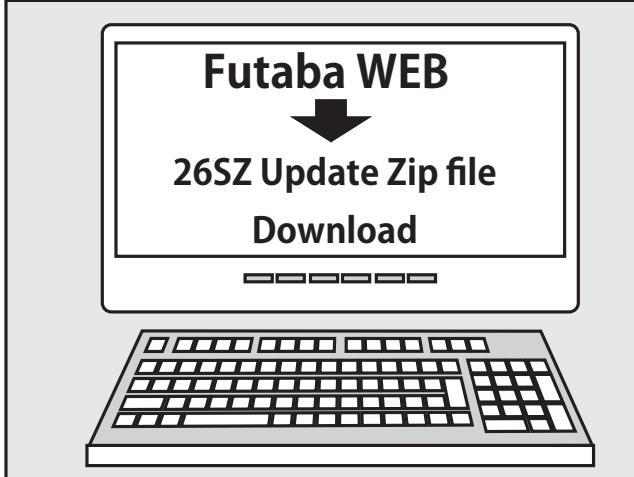
- Note: If the battery fully discharges during program updating, updating will fail. When the remaining battery capacity is 50% or less, always recharge the battery before updating.
- Note: The model data in the transmitter can be used unchanged after updating, but to be safe, back up the model data before updating.
- 1. Download the zip file of the update data from our website.

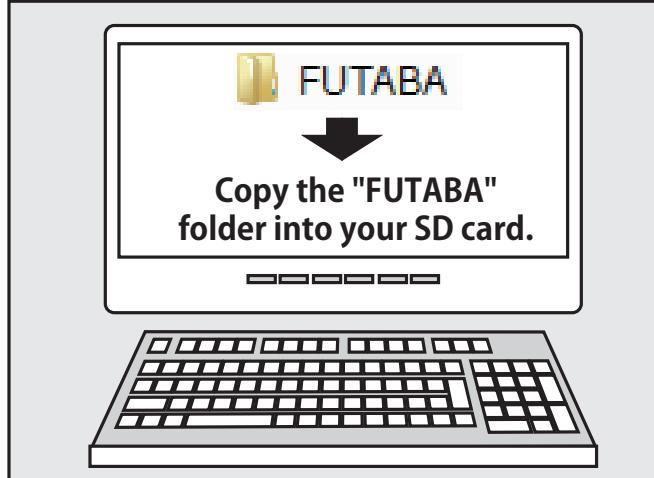
- 2. Extract the zip file on your computer.
- 3. The "FUTABA" folder will be created on your computer.
- 4. Copy the "FUTABA" folder into your microSD card.

Note: If the microSD card has already had "another FUTABA" folder before you make a copy, the "FUTABA" folder is OVERWRITTEN.

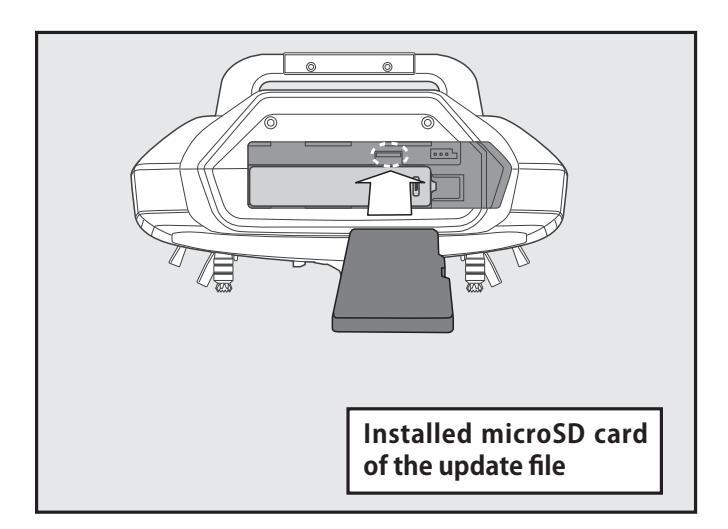
5. Insert the microSD card with "FUTABA" folder that contained the update software into the SD card slot on your T26SZ radio transmitter.

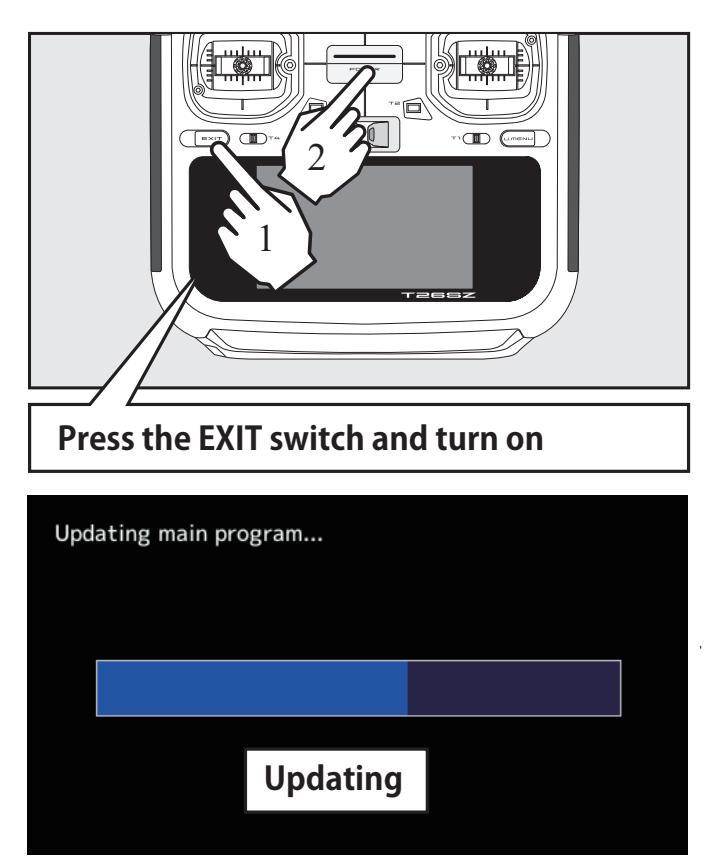
6. Turn on the transmitter power while pressing down the "EXIT" button. The update screen appears on the LCD display of your T26SZ and the software update is started.

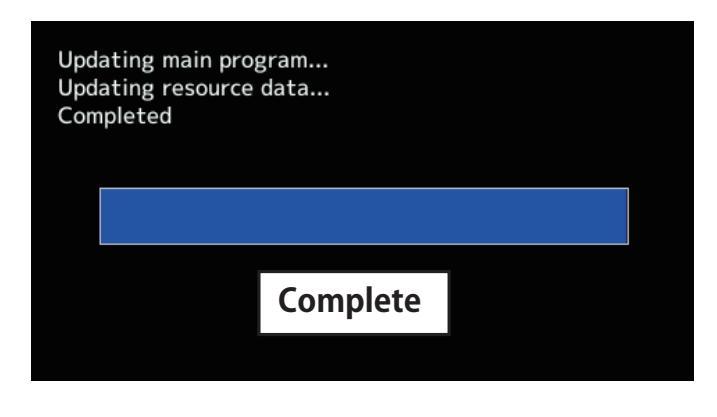
7. When the software update is completed, "Completed" message is shown on the LCD display of your T26SZ. (Show below picture.)

8. Turn off the power switch of your T26SZ and remove the microSD card from the card slot.
